## Notice to Owners of Ruger M77 Bolt Action Rifles

Ruger M77 Rifle

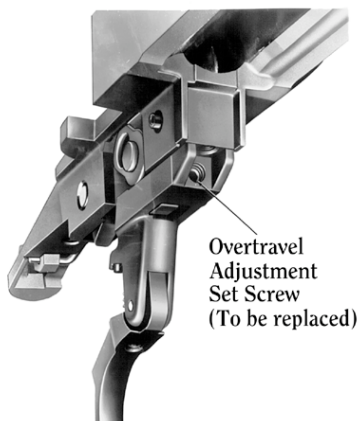
Sturm, Ruger manufactured M77 bolt action rifles from 1968 to 1991. The trigger overtravel adjustment set screw (shown on right) in a few of these rifles may not be securely tightened and may move too readily. This change in original adjustment can, in extreme cases, either cause the rifle to fire unexpectedly (with the safety "off) or cause the rifle to not fire at all. This may occur suddenly and without warning.

For your safety, we ask that all owners of M77 rifles (except those with a "T" underneath the bolt handle) contact us, using the coupon below.

You will receive a new locking screw that will replace your present overtravel adjustment set screw and detailed instructions for quick, easy installation. *There is no charge for this service* and replacing the screw will have no adverse effect on trigger pull.

**Do not use your M77 rifle until you have received and installed the replacement screw.**
